**Flood Control Project Maintenance
Levee Inspections**

Maintenance Issue Types Only, Levee Inspection Report By Mile - Spring 2017

Reclamation District No. 2031 Elliot

Waterway	Bank	Unit Miles	Inspection Start/End	Inspector
Unit No. 01 Stanislaus River	Left	7.07	04/25/2017 04/25/2017	Maksim Khashchuk

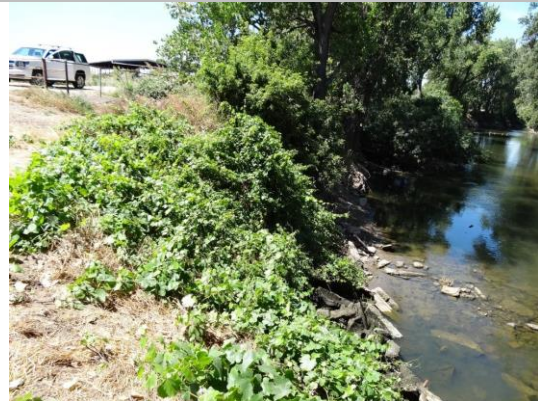
Photo 1 of 2 : SP_2017_RD2031_307_1_20170407_00001.jpg

LM Start	0.45	Rating **	M	Issue No.	1 (cont)
LM End	0.48	Issue Type +	Ma	Location *	WS

Direct view of the site.

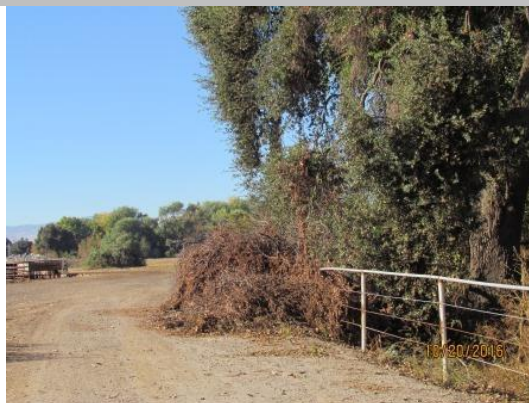
Photo 1 of 3 : SP_2017_RD2031_307_2_20170407_00003.jpg

LM Start	0.48	Rating **	U	Issue No.	2 (cont)
LM End	0.51	Issue Type +	Ma	Location *	WS

View of the large tree branch on the waterside levee slope. Fall 2016

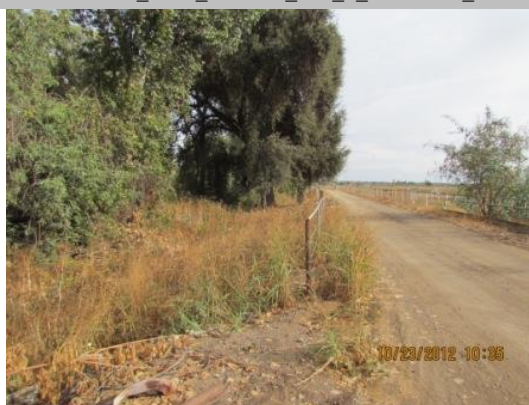
Photo 2 of 3 : SP_2017_RD2031_307_2_20170407_00004.jpg

View of vegetation on waterside slope. Facing upstream.

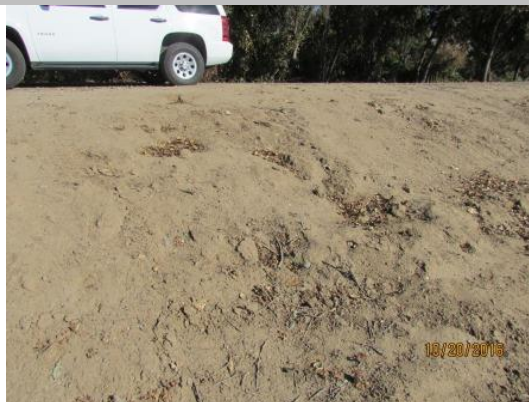
Photo 1 of 3 : SP_2017_RD2031_307_59_20170407_00042.jpg

LM Start	1.00	Rating **	M	Issue No.	59
LM End	1.00	Issue Type +	Ma	Location *	LS
Category	Earthen Levee			GPS Latitude/Longitude	
				Start	End
Item	Animal Control			37.699327 °	37.699327 °
				-121.165364 °	-121.165364 °
DWR ID	DWR_RD2031_01_f_2014_59				
Comment Code					
A3 : No rodents visible, but rodent burrows visible; need to backfill and compact or grout burrows.					
Inspector Comment					
Some of the rodent holes have collapsed.

View of the rodent holes on the landside levee slope.

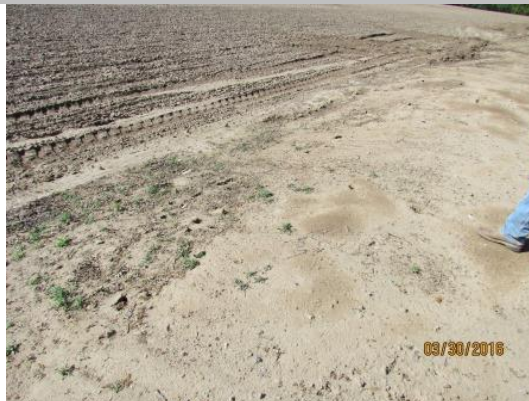
Photo 3 of 3 : SP_2017_RD2031_307_59_20170407_00044.jpg

LM Start	1.00	Rating **	M	Issue No.	59 (cont)	
LM End	1.00	Issue Type +	Ma	Location *	LS	
Category	Earthen Levee			GPS Latitude/Longitude		
				Start		End
Item	Animal Control			37.699327 °		37.699327 °
				-121.165364 °		-121.165364 °
DWR ID	DWR_RD2031_01_f_2014_59					
Comment Code						
A3 : No rodents visible, but rodent burrows visible; need to backfill and compact or grout burrows.						
Inspector Comment						
Some of the rodent holes have collapsed.

View of the multiple rodent holes on the landside levee slope.

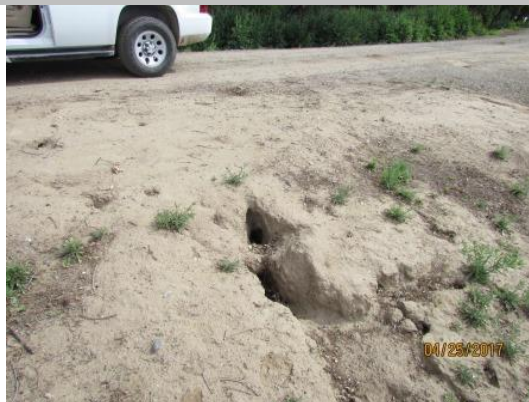
Photo 1 of 2 : SP_2017_RD2031_307_44_20170427_00112.jpg

LM Start	1.16	Rating **	M	Issue No.	44
LM End	1.16	Issue Type +	Ma	Location *	LS
Category	Earthen Levee			GPS Latitude/Longitude	
				Start	End
Item	Animal Control			37.698848 °	37.698848 °
				-121.168088 °	-121.168088 °
DWR ID	DWR_RD2031_01_f_2016_44				
Comment Code					
A3 : No rodents visible, but rodent burrows visible; need to backfill and compact or grout burrows.					
Inspector Comment

View of the rodent holes on the landside levee slope.

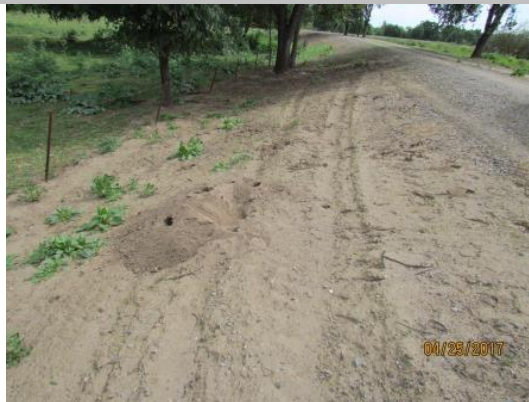
Photo 1 of 1 : SP_2017_RD2031_307_63_20170427_00114.jpg

LM Start	1.59	Rating **	M	Issue No.	63
LM End	1.59	Issue Type +	Ma	Location *	LS
Category	Earthen Levee			GPS Latitude/Longitude	
				Start	End
Item	Animal Control			37.698555 °	37.698555 °
				-121.174737 °	-121.174737 °
DWR ID	DWR_RD2031_01_s_2017_63				
Comment Code					
A1 : Exterminate rodents and backfill and compact or grout burrows.					
Inspector Comment

View of the rodent holes on the levee slope.

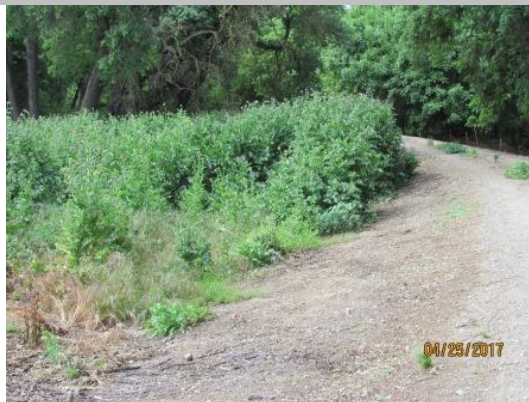
Photo 1 of 2 : SP_2017_RD2031_307_29_20170427_00115.jpg

LM Start	1.73	Rating **	U	Issue No.	29
LM End	1.86	Issue Type +	Ma	Location *	LS
Category	Earthen Levee			GPS Latitude/Longitude	
				Start	End
Item	Vegetation			37.697477 °	37.695818 °
				-121.176953 °	-121.177542 °
DWR ID	DWR_RD2031_01_s_2016_29				
Comment Code					
V2 : Remove the wild growth other than native grasses from the levee slopes.					
Inspector Comment					
Maintain vegetation 12 inches tall or less on levee slope and within 10 feet of levee toe.

View of the tall vegetation on the landside levee slope.

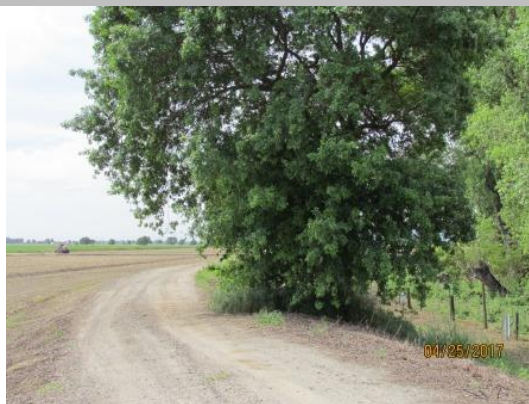
Photo 1 of 1 : SP_2017_RD2031_307_65_20170427_00117.jpg

LM Start	2.24	Rating **	M	Issue No.	65
LM End	2.24	Issue Type +	Ma	Location *	WS
Category	Earthen Levee			GPS Latitude/Longitude	
				Start	End
Item	Trim / Thin Trees			37.690438 °	37.690438 °
				-121.178576 °	-121.178576 °
DWR ID	DWR_RD2031_01_s_2017_65				
Comment Code					
T1 : Trim trees to at least five feet above ground level.					
Inspector Comment

View of the tree that needs to be trimmed.

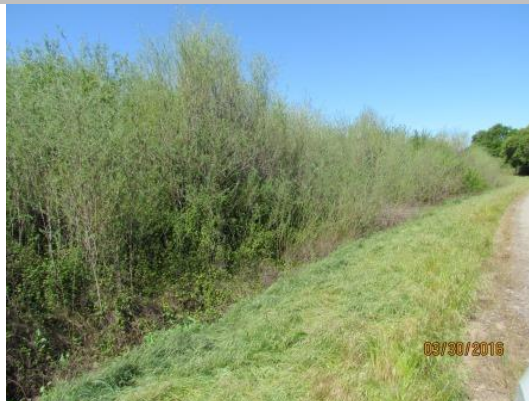
Photo 2 of 4 : SP_2017_RD2031_307_33_20170407_00020.jpg

LM Start	3.69	Rating **	U	Issue No.	33 (cont)
LM End	4.38	Issue Type +	Ma	Location *	LS
Category	Earthen Levee			GPS Latitude/Longitude	
				Start	End
Item	Vegetation			37.689718 °	37.686658 °
				-121.198833 °	-121.207747 °
DWR ID	DWR_RD2031_01_f_2016_33				
Comment Code					
V2 : Remove the wild growth other than native grasses from the levee slopes.					
Inspector Comment					
Trim back woody vegetation at least 15 feet away from the landside levee toe.

Typical view of the tall vegetation on the landside levee slope and toe in this area.

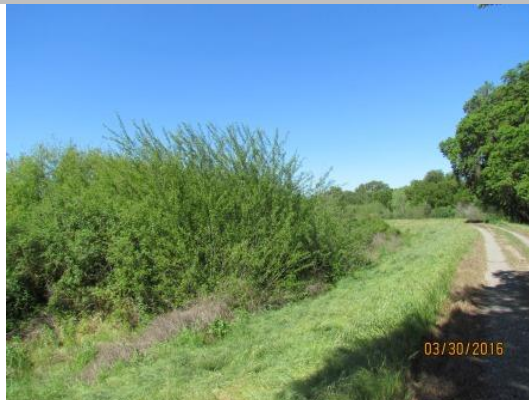
Photo 3 of 4 : SP_2017_RD2031_307_33_20170407_00019.jpg

View of the tall vegetation on the landside levee slope and toe.

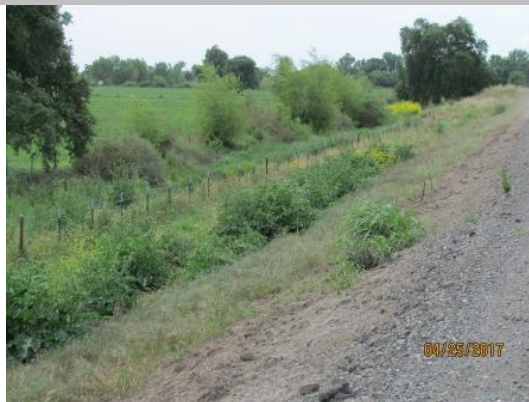
Photo 1 of 1 : SP_2017_RD2031_307_72_20170427_00125.jpg

LM Start	5.33	Rating **	M	Issue No.	72
LM End	5.77	Issue Type +	Ma	Location *	LS
Category	Earthen Levee			GPS Latitude/Longitude	
				Start	End
Item	Vegetation			37.677907 °	37.671800 °
				-121.217482 °	-121.218800 °
DWR ID	DWR_RD2031_01_s_2017_72				
Comment Code					
V1 : Control annual grass and weeds on the levee slopes and easements.					
Inspector Comment

View of the vegetation on the levee slope.

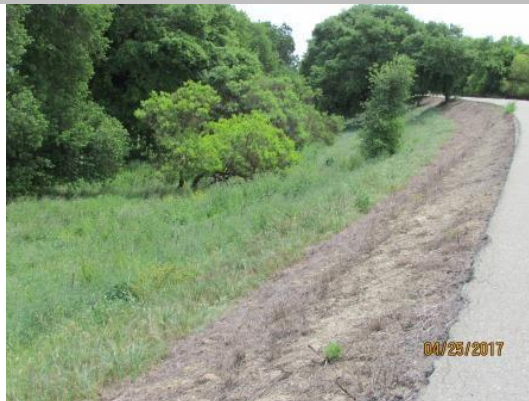
Photo 1 of 1 : SP_2017_RD2031_308_23_20170427_00047.jpg

LM Start	0.46	Rating **	M	Issue No.	23
LM End	0.46	Issue Type +	Ma	Location *	LS
Category	Earthen Levee			GPS Latitude/Longitude	
				Start	End
Item	Vegetation			37.655708 °	37.655708 °
				-121.234404 °	-121.234404 °
DWR ID	DWR_RD2031_02_s_2017_23				
Comment Code					
V1 : Control annual grass and weeds on the levee slopes and easements.					
Inspector Comment

View of the vegetation on the levee slope.

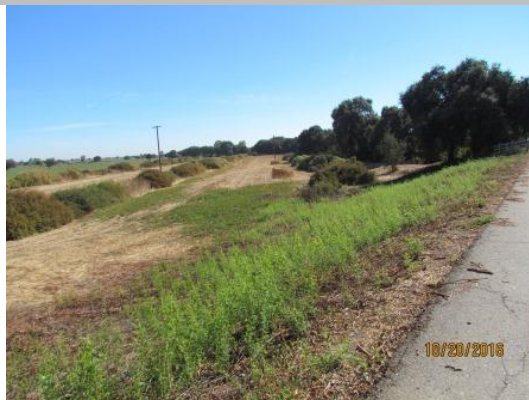
Photo 1 of 2 : SP_2017_RD2031_308_965_20170407_00009.jpg

LM Start	1.42	Rating **	A/W	Issue No.	965
LM End	1.46	Issue Type +	Ma	Location *	LS
Category	Earthen Levee			GPS Latitude/Longitude	
				Start	End
Item	Vegetation			37.648005 °	37.647476 °
				-121.221039 °	-121.220766 °
DWR ID	DWR_RD2031_02_s_2012_965				
Comment Code					
V2 : Remove the wild growth other than native grasses from the levee slopes.					
Inspector Comment					
Wild rose bush on landside slope. LMA mowed the shrubs in fall 2016. Site must be maintained or shrubs will grow back.

View of wild rose emerging on levee slope. Fall 2016.

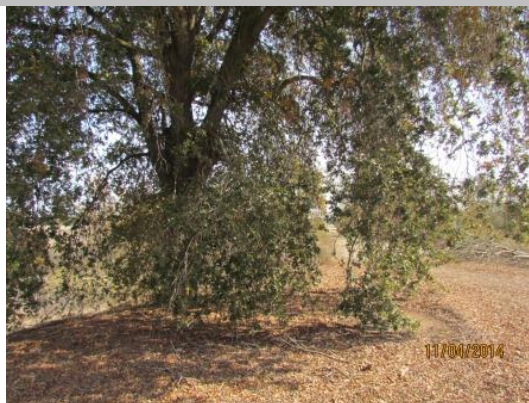
Photo 1 of 1 : SP_2017_RD2031_308_25_20170407_00007.jpg

LM Start	2.01	Rating **	M	Issue No.	25
LM End	2.01	Issue Type +	Ma	Location *	LS
Category	Earthen Levee			GPS Latitude/Longitude	
				Start	End
Item	Trim / Thin Trees			37.640874 °	37.640874 °
				-121.223870 °	-121.223870 °
DWR ID	DWR_RD2031_02_f_2014_25				
Comment Code					
T1 : Trim trees to at least five feet above ground level.					
Inspector Comment

View of the overgrown tree obstructing visibility and access of the landside levee slope.

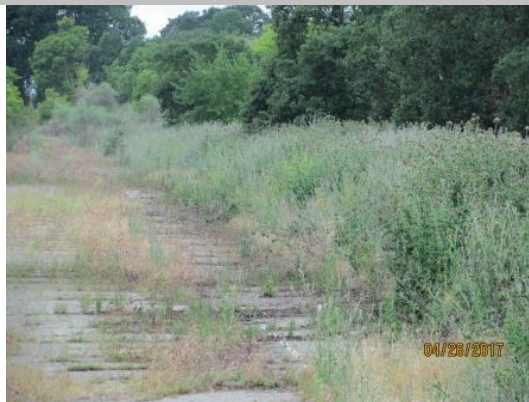
Photo 1 of 2 : SP_2017_RD2031_308_21_20170427_00051.jpg

LM Start	2.14	Rating **	M	Issue No.	21
LM End	2.34	Issue Type +	Ma	Location *	CR
Category	Earthen Levee			GPS Latitude/Longitude	
				Start	End
Item	Vegetation			37.640632 °	37.640217 °
				-121.221539 °	-121.217874 °
DWR ID	DWR_RD2031_02_f_2014_21				
Comment Code					
V2 : Remove the wild growth other than native grasses from the levee slopes.					
Inspector Comment

View of overgrown vegetation on the levee crown.
